LANE 2010

Avoidance of Crack Inducement when Laser Welding Hot-formed Car Body Components – A Variable Analysis

Volvo Car Corporation, Dept. 93711 – PVÖS 22, SE-405 31 Gothenburg, SWEDEN

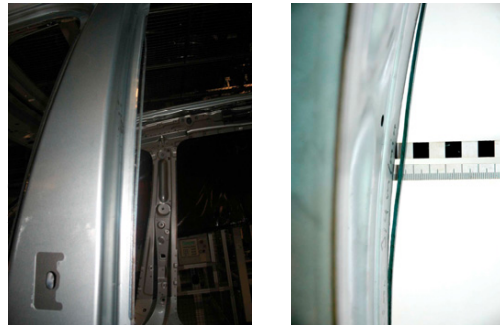
During early prototype build it was experienced that cracking occurred in the B-pillar application during welding [Fig. 1]. Therefore, one such pillar was cut out and sent to Volvo Materials Technology for further analysis. No exceptional impurity from alloy elements such as Sulphur or Phosphorus was detected, nor a high Carbon content, and the weld geometry did not differ from the normal appearance of a laser weld. Therefore, classic hot-cracking could be excluded as the root cause of the phenomena, although the oxidized surfaces of the crack indicated that the fracture had taken place at high temperature when the weld still had a low strength.

Fig. 1. The appearance of laser weld cracking in the XC60 B-pillar during early prototype build in the Pilot Plant facilities

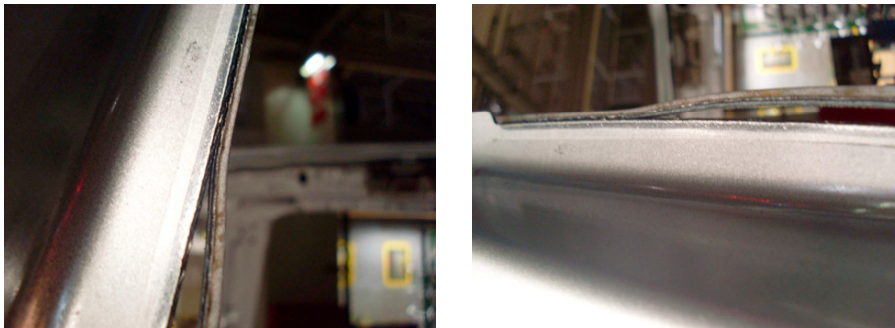
It is obvious that the heat distribution at laser welding is the root cause for crack initiation. If we take a closer look at the parameters involved they can be described according to **Figure 8**. During welding the small sheet strip between the weld location and the flange cut edge will expand due to the temperature difference, but is constricted to do so due to the surrounding material. The strip will then plasticize under the pressure, and will therefore be too short after cooling which leads to the "bow-like" separation which can be seen in **Figure 9**.

Fig. 9. The visual appearance of the "bow-like" separation in the B-pillar region during early prototyping trials

- Secure the sheet strip, b , to be larger than approximately 3 mm.
- Weld intermittent instead of continuous in order to minimize heat input and the risk of buckling behaviour
- Secure the correct energy density (laser power and focal point position) in order to minimize variations in heat input
